1315 DUKE STREET (FREEDOM HOUSE) HISTORIC STRUCTURE REPORT

**PUBLIC PRESENTATION
OCTOBER 28, 2021**

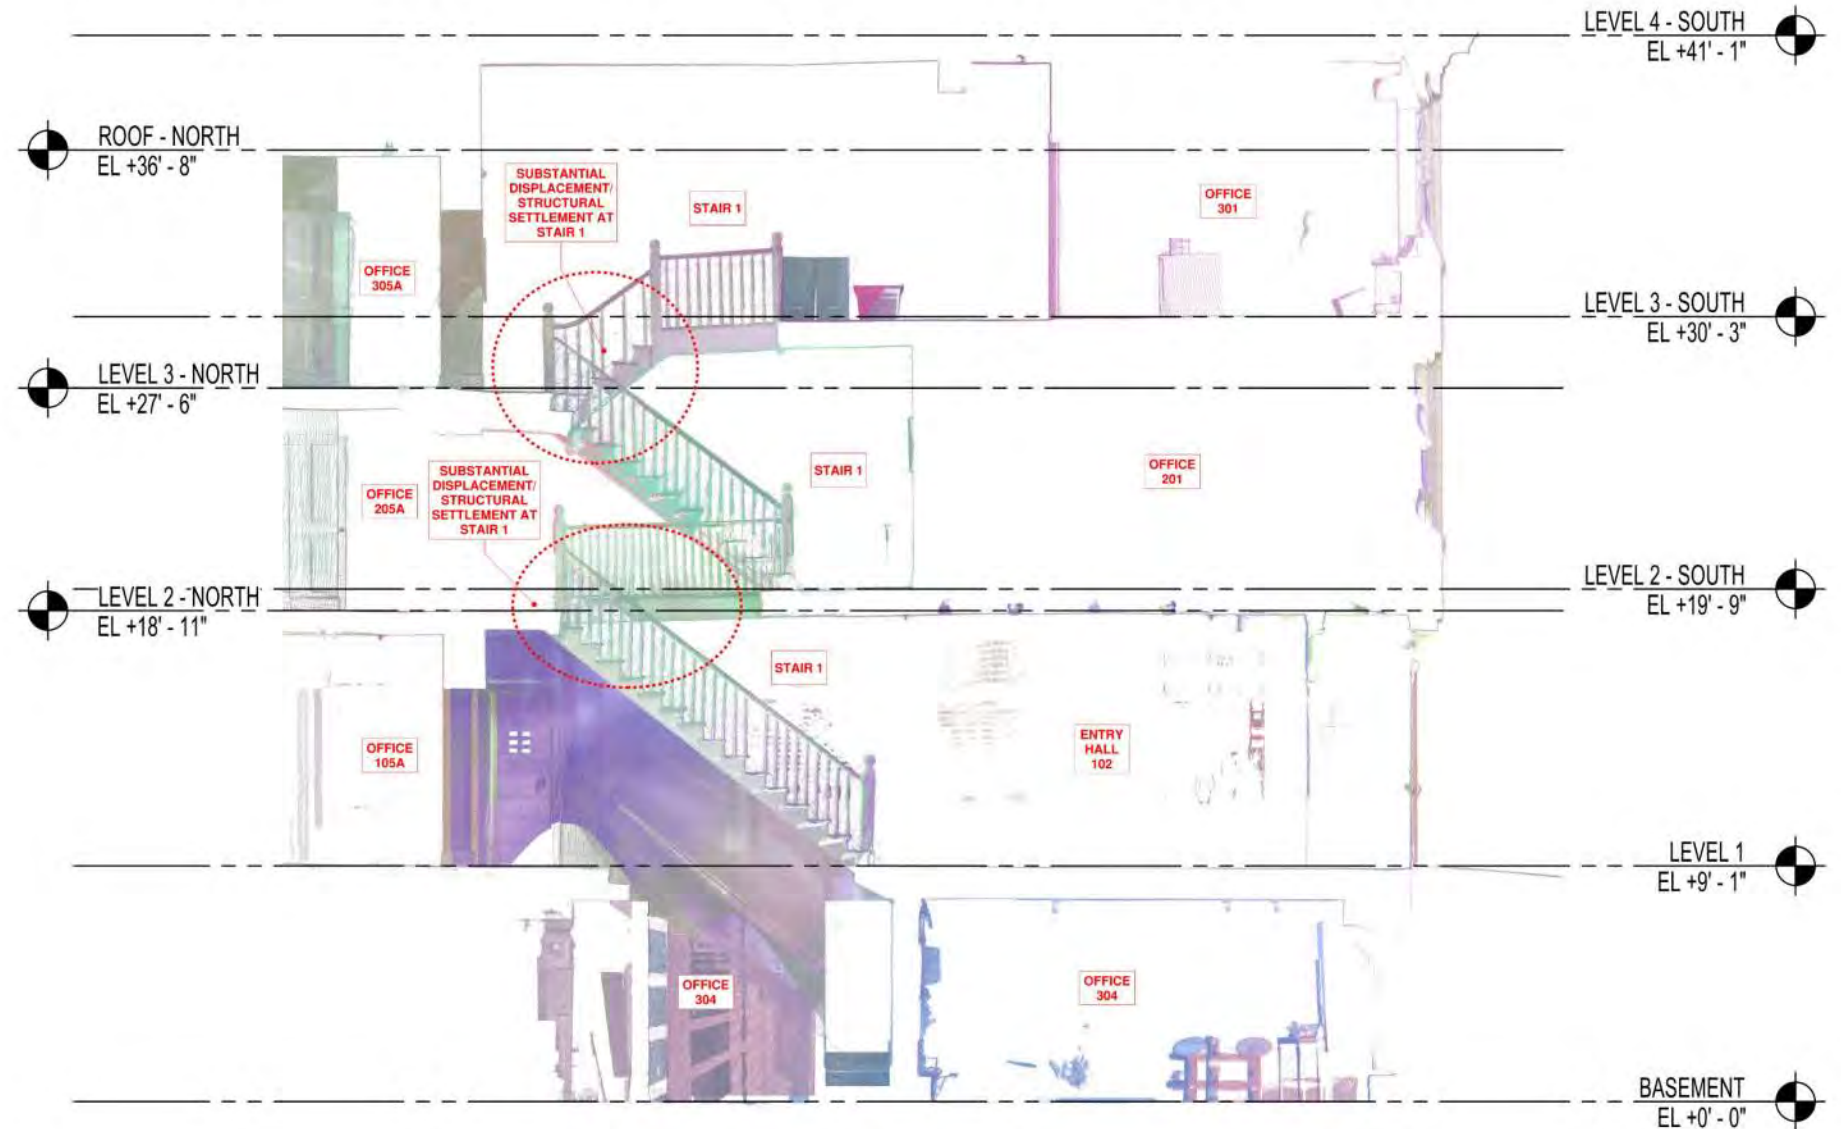
- Used FARO 3D laser scanner
- Point cloud data supported the creation of highly accurate drawings
- Support the creation of a REVIT model that served to develop chronology diagrams
- Highlighted structural issues that have resulted in significant deflection at the primary staircase

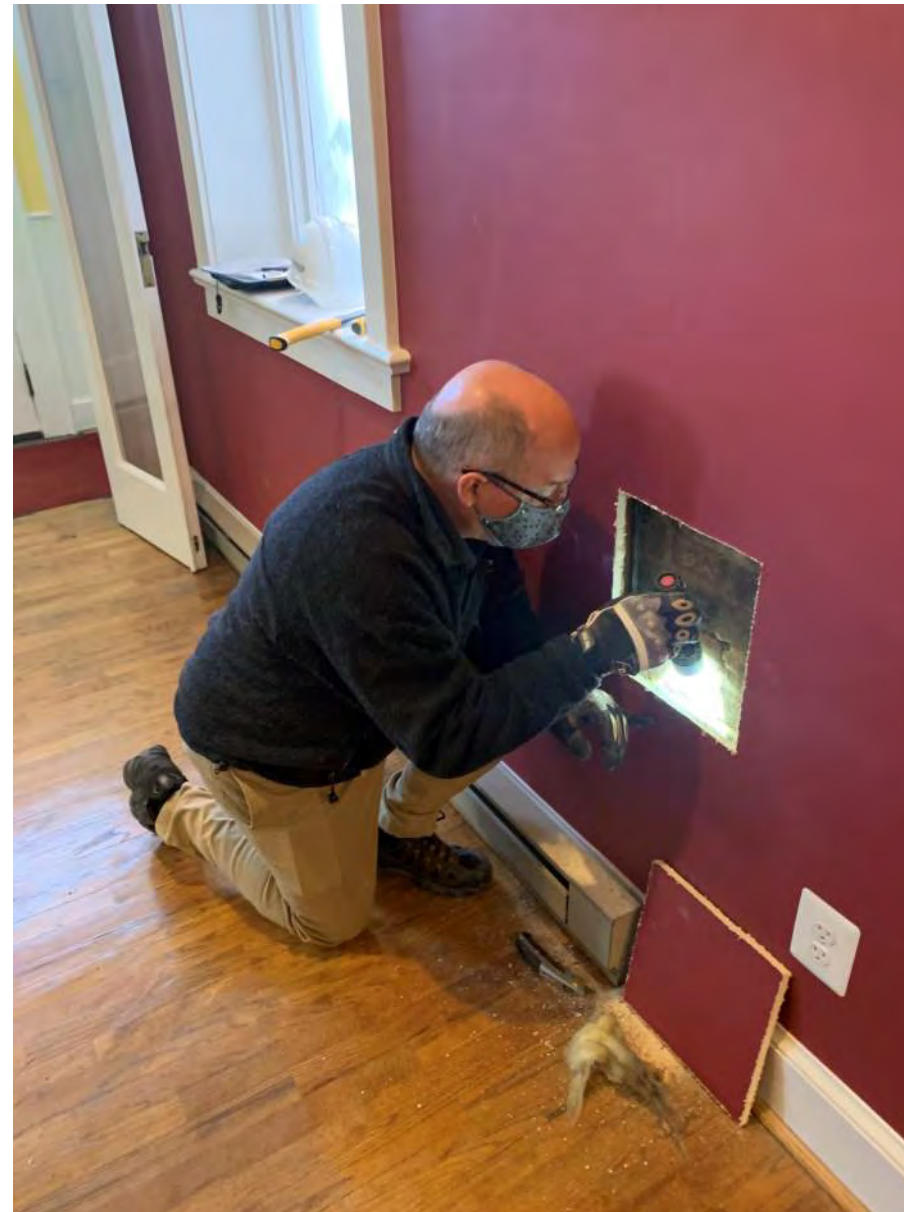
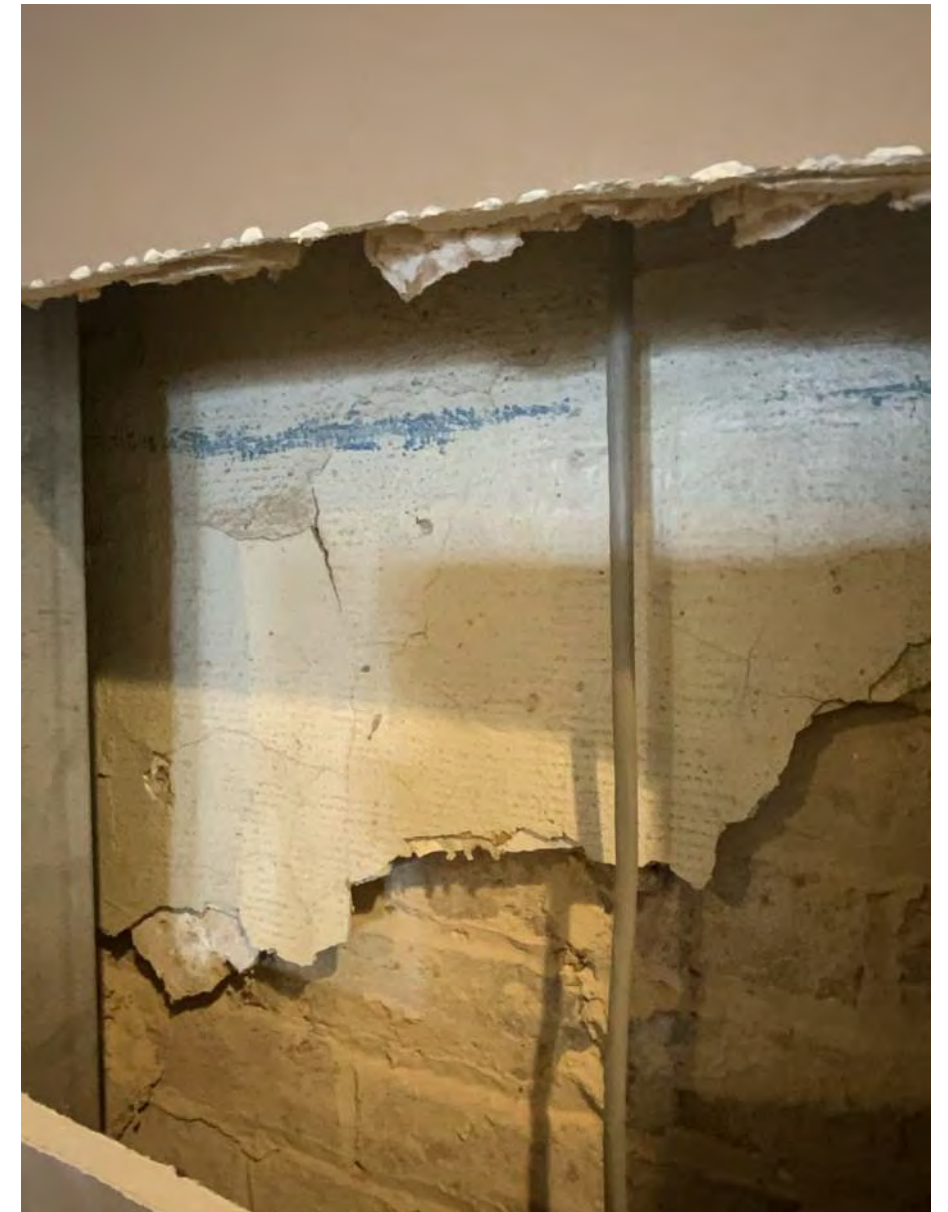
- 19 probes implemented to reveal more information about what existing historic fabric remained
- Opening of walls revealed historic plaster, concealed doors, and structural framing

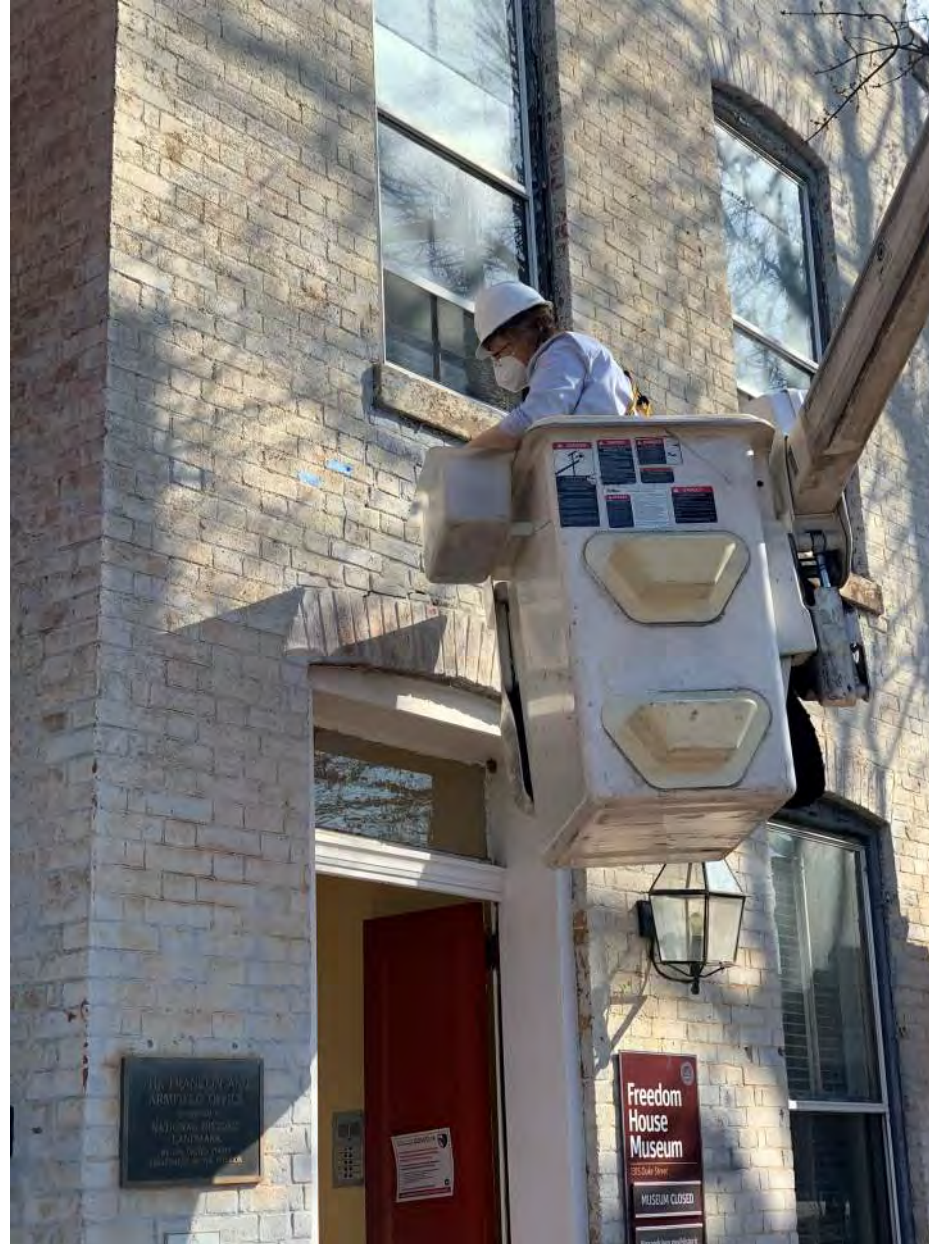
- IMAGE D**

THIS IMAGE POSSIBLY DATES TO FEBRUARY 1862 IMMEDIATELY AFTER UNION SOLDIER PROZE TO DEATH. IT IS POSSIBLE THAT THE CONSTRUCTION OF THE FULL ROOF WITH CONTINUOUS MONITOR COINCIDED WITH CONSTRUCTION OF THE PRISON CELLS SEEN ALONG THE NORTH WALL OF THE MENS' YARD

E-10: PERIOD 3 INCREASE IN HEIGHT OF WALL APPROXIMATELY 4-6 FEET (3 BRICK COURSES). THE LACK OF WHITEWASH IN THIS AREA AND CHARRED WHITEWASH AS SEEN BELOW LEADS TO THE BELIEF THIS WALL WAS INCREASED IN HEIGHT AFTER FEBRUARY 4, 1862 FOLLOWING SOLDIER FREEZING TO DEATH (FEBRUARY 1862) AS THE FACE OF THIS BRICK WAS NEVER AN INTERIOR CONDITION.

E-8: CHARRED BRICK RESULTING FROM A FIRE LOCATED ADJACENT TO WALL ASSOCIATED DOCUMENTATION OF THIS FIRE MAY BE SEEN IN THE NEW YORK ILLUSTRATED WHICH SHOWS A FIRE ALONG WHAT IS ASSUMED TO BE THE NORTH WALL OF THE MENS' YARD.

E-11: ROOF RAFTERS ABOVE MENS' YARD. FULL ROOF WITH CONTINUOUS MONITOR INSTALLED AFTER FEBRUARY 4, 1862 FOLLOWING SOLDIER FREEZING TO DEATH (FEBRUARY 1862). FULL ROOF WITH TWO (2) SEPARATE LANTERNS INSTALLED BETWEEN MARCH, APRIL 1864 AND APRIL 1865.

E-4: ASSUMED PROJECTION OF L SHAPED REVERSE SLOPE SHED ROOF AT NORTH AND EAST SIDES OF THE MENS' YARD AS DEPICTED IN THE NEW YORK ILLUSTRATED NEWS IMAGE PUBLISHED IN MARCH 1862.

E-7: BEAM SUPPORT OF EARLIER SHED ROOF WHICH ALONG WITH HEAVY TIMBER WOOD POST BELOW

E-17: CIVIL WAR GRAFFITI ON BRICK WALL

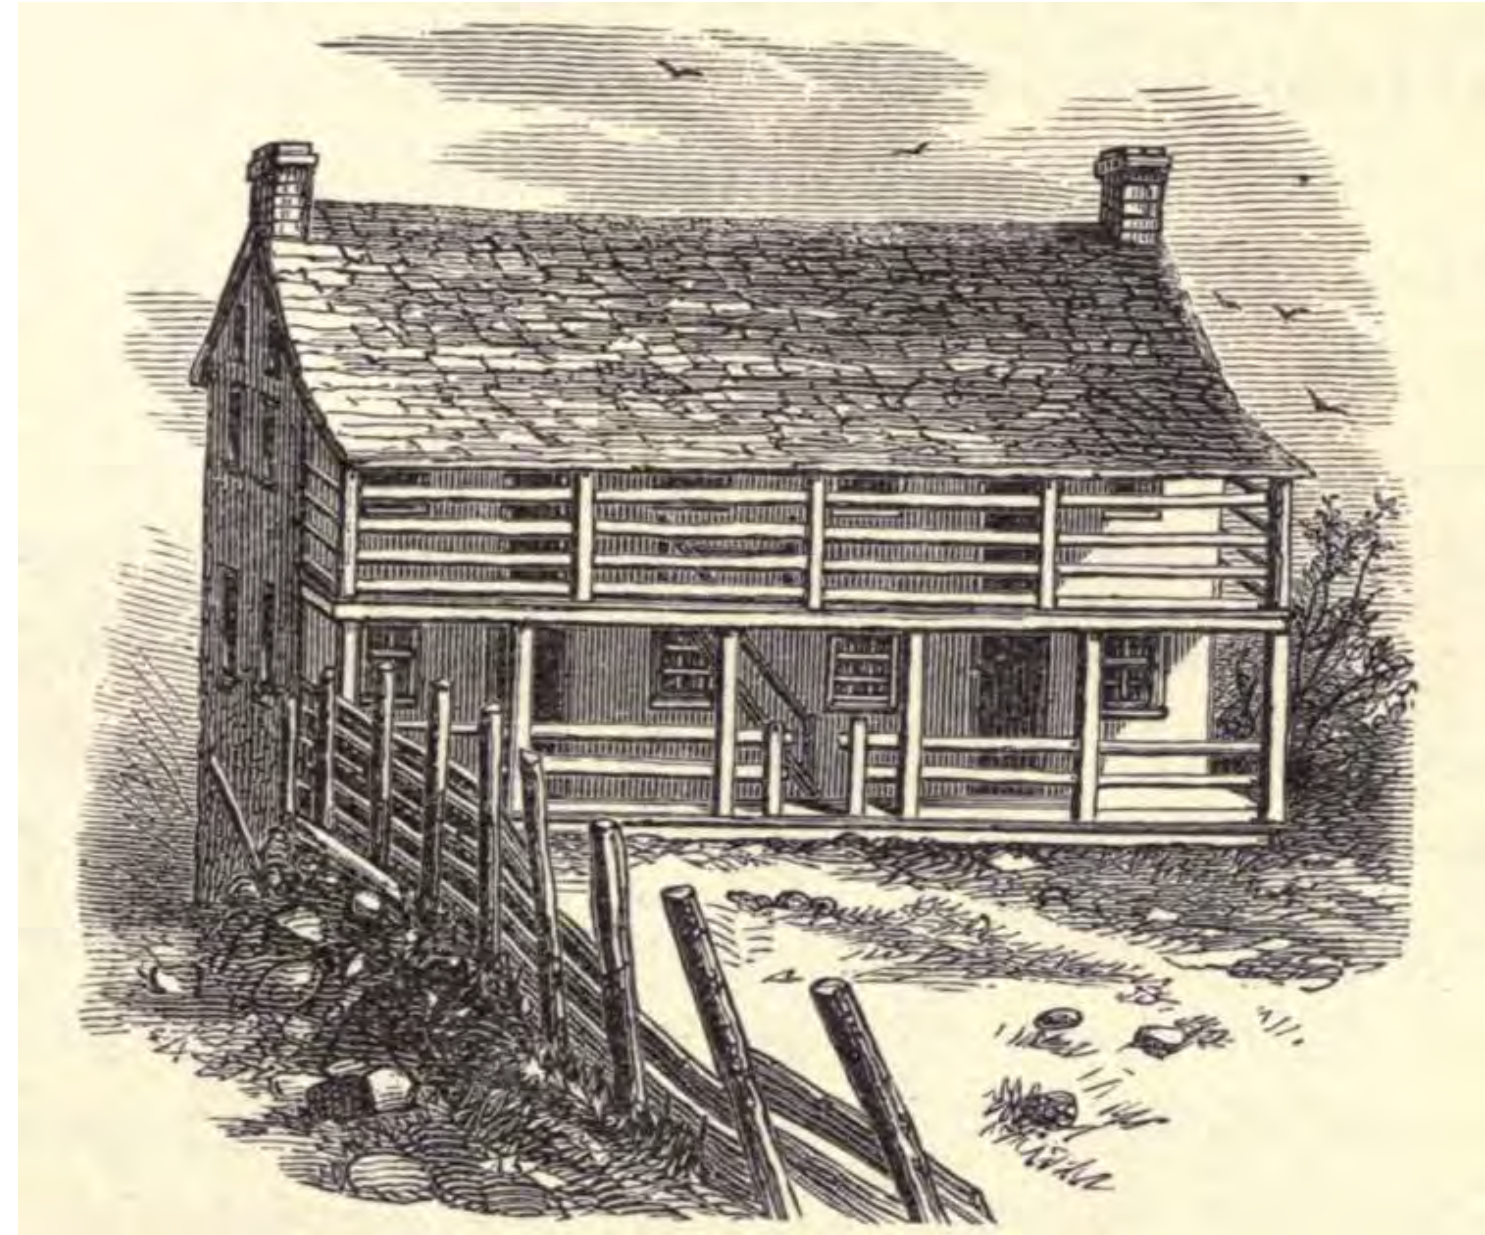
Engraving of the jail at Lumpkin's slave pen in Richmond. From Charles H. Corey's *A History of the Richmond Theological Seminary*

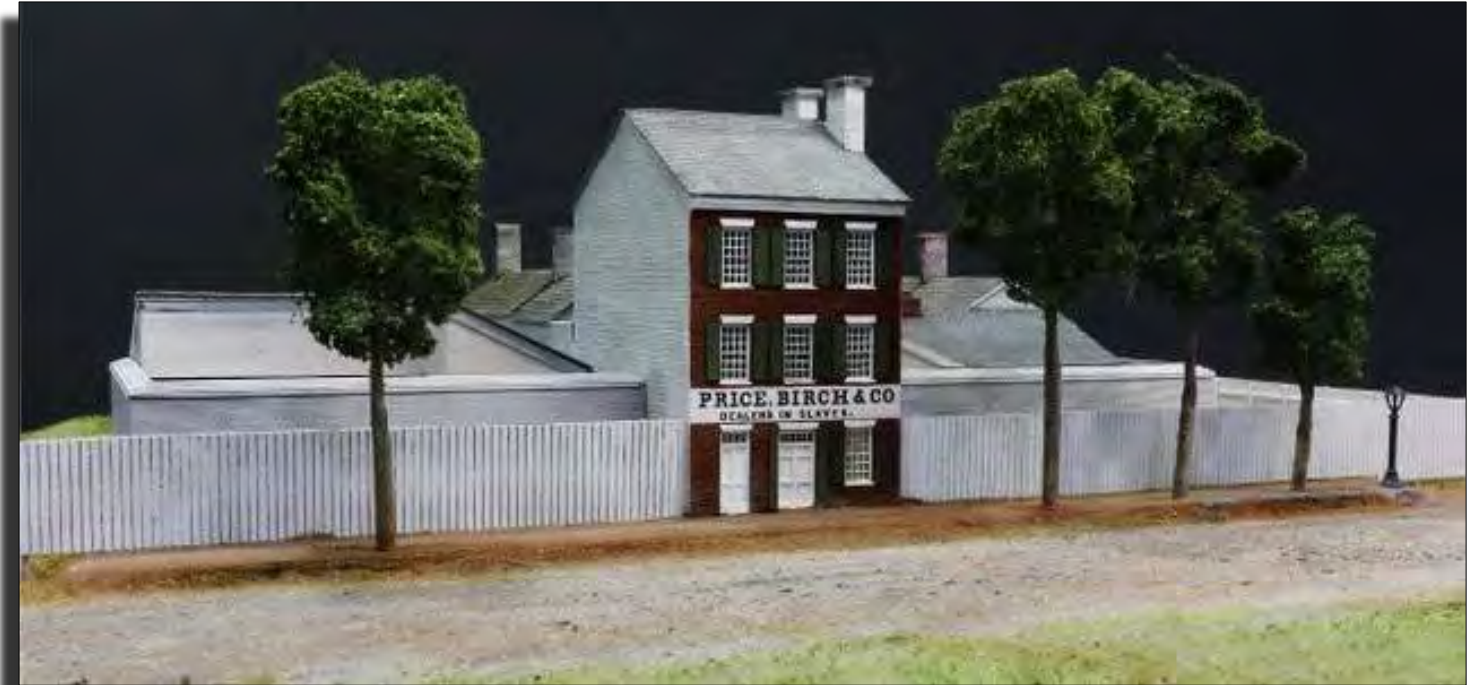
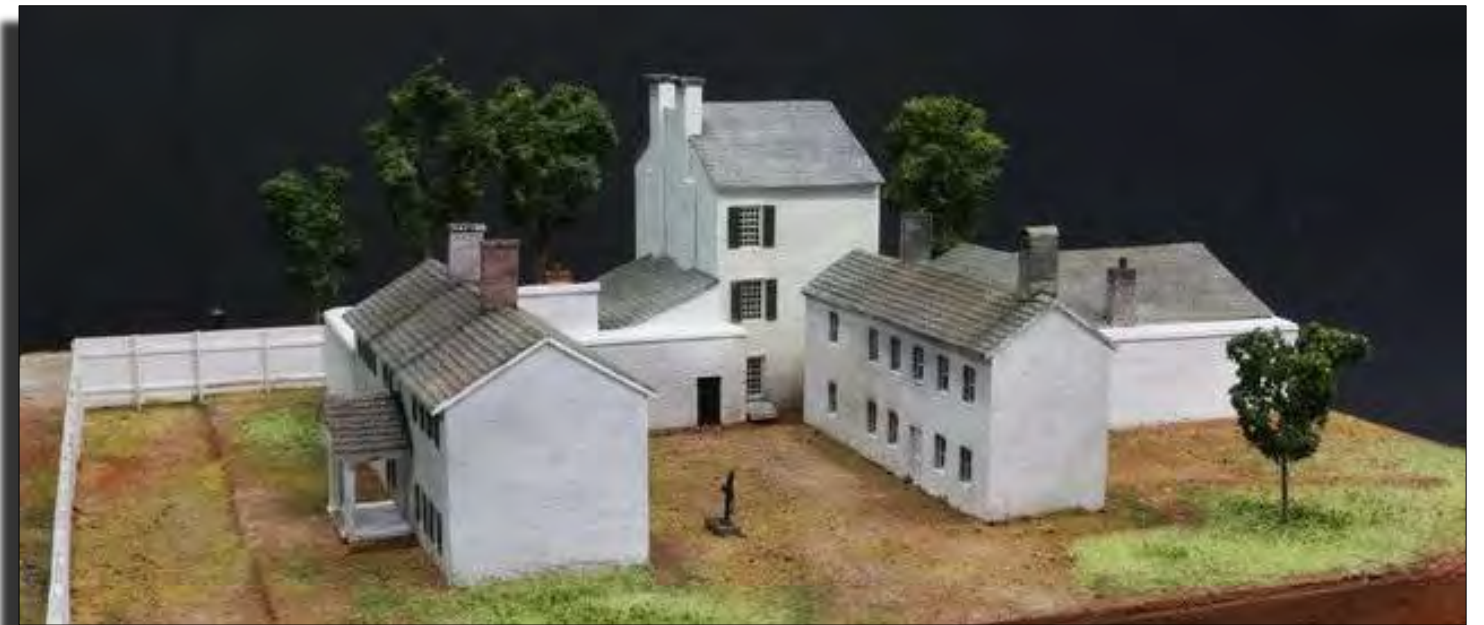
Scaled model by Bernard Kempinski, Alkem Scale Models - www.alkemscalemodels.com

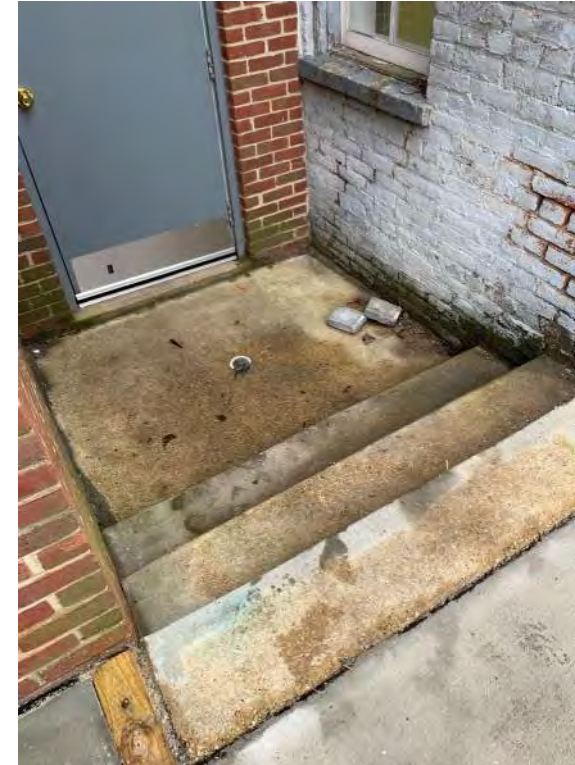
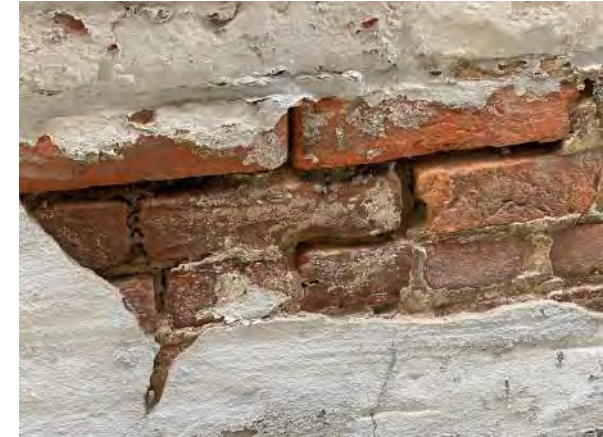
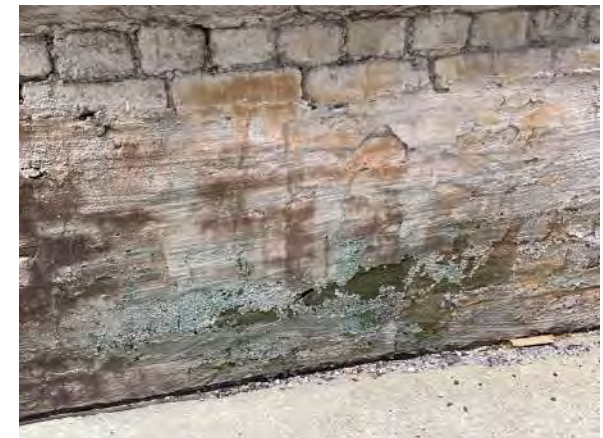
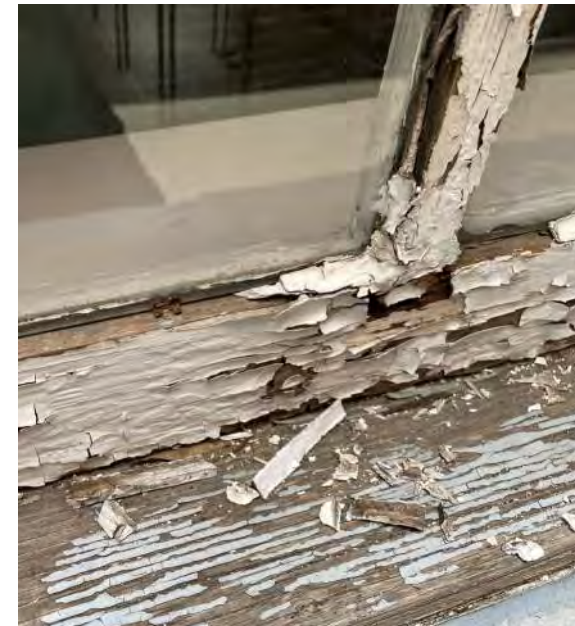
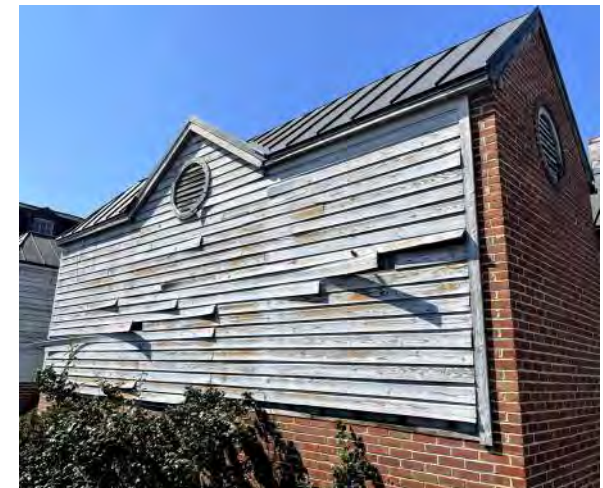
- Implement exterior masonry repairs and re-pointing
- Repair and repaint wood siding
- Restore/replace existing windows and make operable
- Repair/replace flashing and parts of roofing
- Re-point and repair chimney and provide chimney caps
- Repair/replace gutters and downspouts

- Correct Stair 1 floor deflection
- Repair ceiling damage on third floor and fourth floor

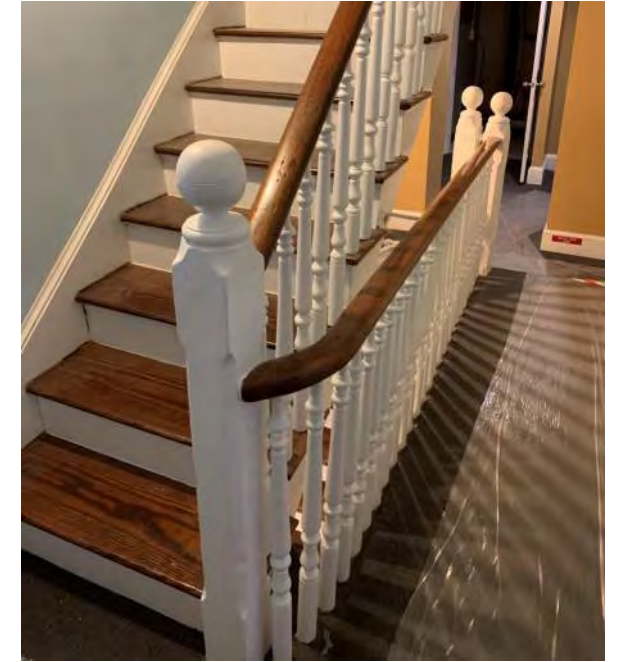
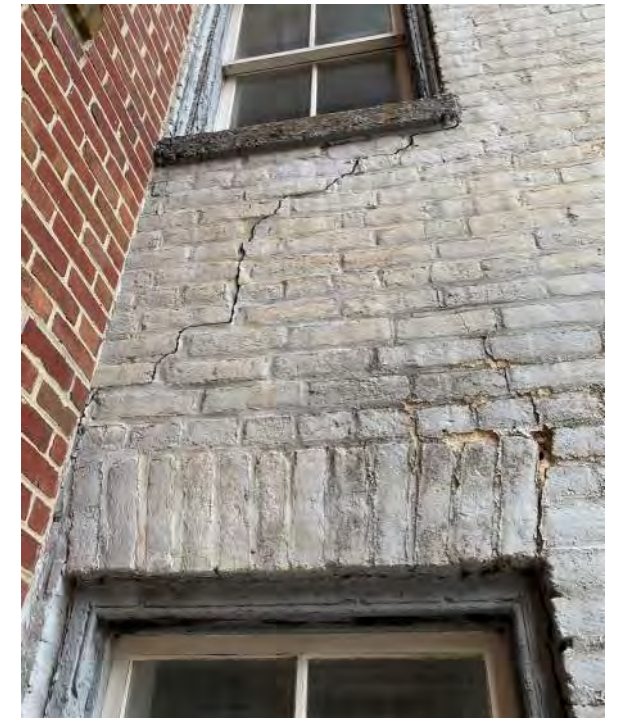
LIVE LOAD CAPACITY DIAGRAMS

- Select rebuilding of the masonry at areas of localized cracking and displacement
- Further study Chimney 1 and 2 to evaluate lateral displacement
- Re-evaluate occupancy and live load at next phase
- Provide localized reinforcement at Stair 1
- Conduct code required seismic evaluation
